National Dam Safety Program  
D.M. (NJ-71447)  
ATLANTIC COASTAL BASIN,  
WRANGEL BROOK, OCEAN COUNTY,  
NEW JERSEY. Phase 1  
Inspection Report.

# UPPER KESWICK DAM

NJ 00047

4. TITLE (and Subtitle) Phase I Inspection Report National Dam Safety Program Upper Keswick Dam, NJ00047 Ocean County, N.J.	5. TYPE OF REPORT & PERIOD COVERED  FINAL	6. PERFORMING ORG. REPORT NUMBER

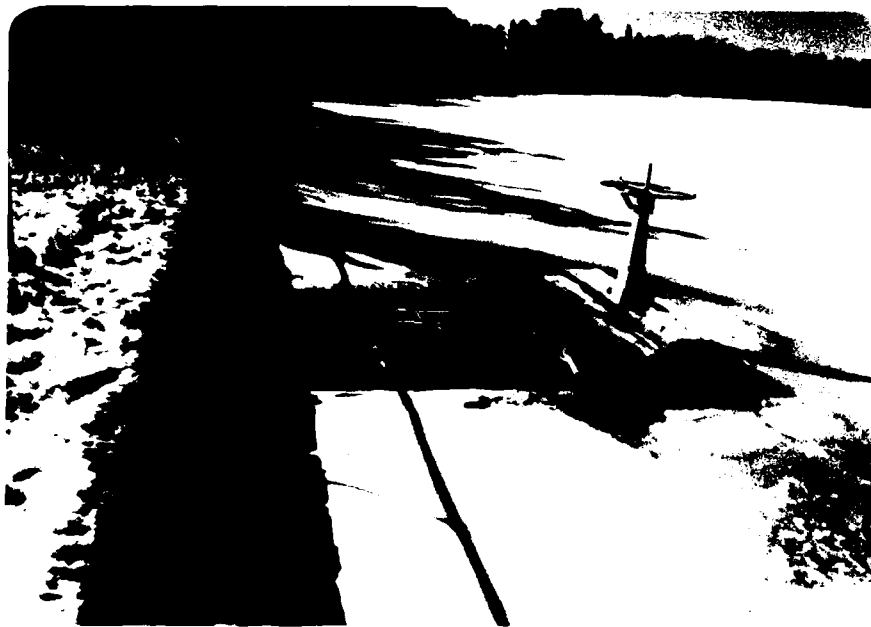
Photo 1 - View of spillway, lake and upstream slope of dam looking to the right. Note brush and small trees on slope.

(4) All trees and brush should be removed from the side slopes to avoid problems which may develop from roots. The embankment face should then be reseeded to develop a growth of grass for surface erosion protection.

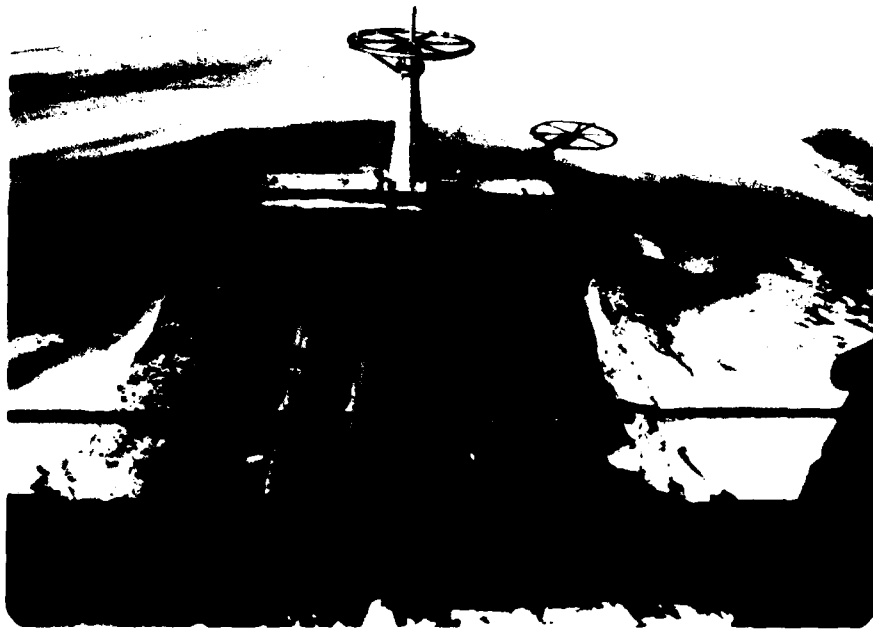
The spillway is in good condition. No cracks in the concrete caps were noted only spalling. The timber trash rack appeared in good condition.

Photo 3 - View of spillway from top of dam.
